**Flood Control Project Maintenance
Levee Inspections**
LMA District Cover Sheet
Spring 2011 Levee Inspection Results

Reclamation District No. 1600 Mull

Spring 2011 Levee Inspection Results

Waterway			Bank	Unit Miles
Unit No. 01 Sacramento River			Right	10.51

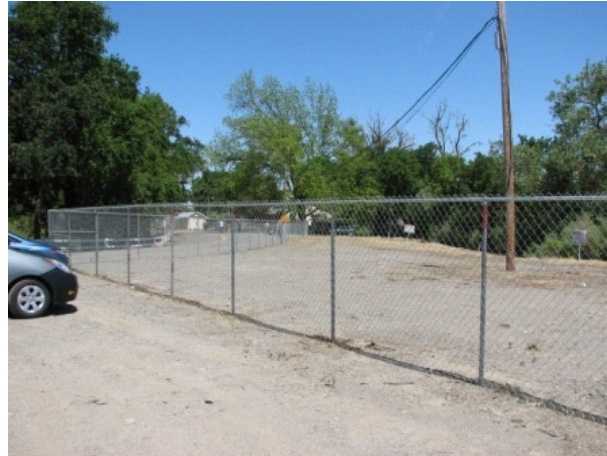
Levee Mile Report Line	1
Start Levee Mile	0.01
End Levee Mile	0.09
Location	Water Side
Category	Earthen Levee
Item	Encroachments
Chain link fence no permit. The building and pumping plant in background is an issue.	
johngw_s_20110228_259.jpg

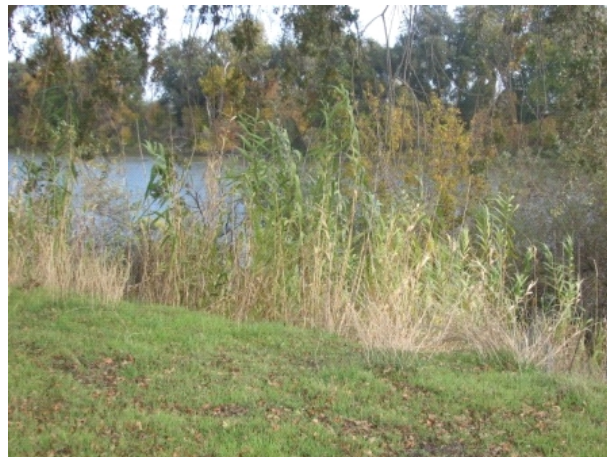
Levee Mile Report Line	3
Start Levee Mile	0.21
End Levee Mile	0.21
Location	Water Side
Category	Earthen Levee
Item	Vegetation
The Arundo is close to the repair area but spreads upstream.	
johngw_s_20110228_257.jpg

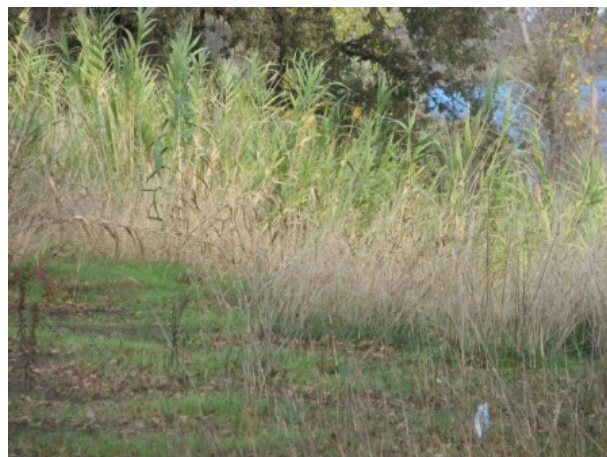
Levee Mile Report Line	3
Start Levee Mile	0.21
End Levee Mile	0.21
Location	Water Side
Category	Earthen Levee
Item	Vegetation
The Arundo has spread upstream and most is below the 20' line on the waterside..	
johngw_s_20110228_258.jpg

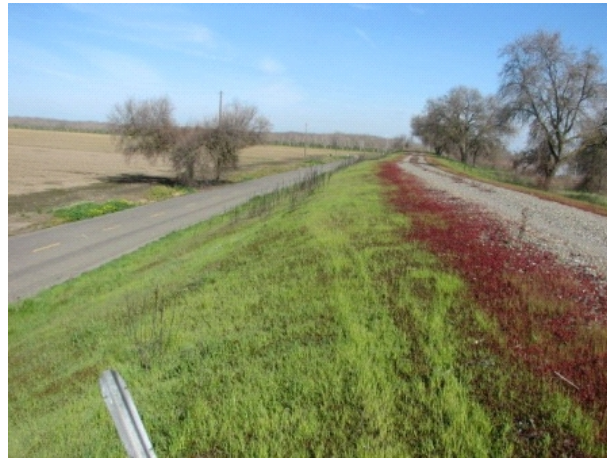
Levee Mile Report Line	4
Start Levee Mile	0.35
End Levee Mile	0.35
Location	Land Side
Category	Earthen Levee
Item	Vegetation

This is a view of the vegetation that is acceptable on the landside.

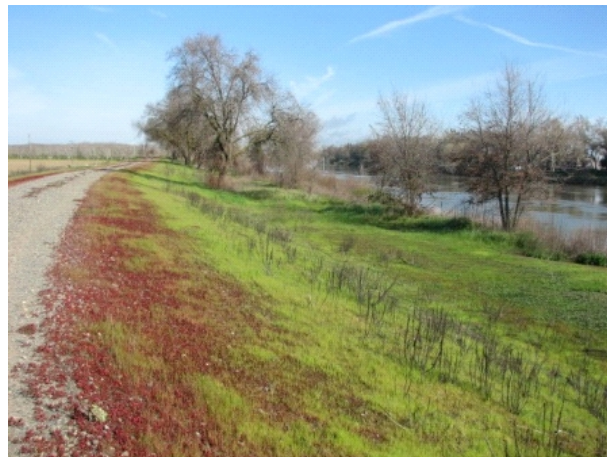
Levee Mile Report Line	5
Start Levee Mile	0.35
End Levee Mile	0.35
Location	Water Side
Category	Earthen Levee
Item	Vegetation

This a view of the vegetation that is acceptable on the waterside.

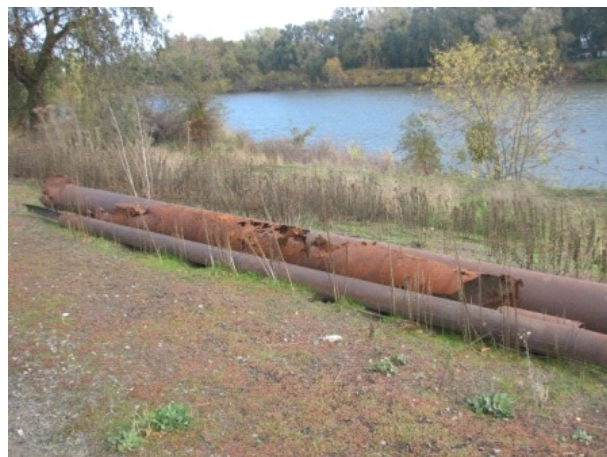
Levee Mile Report Line	6
Start Levee Mile	0.54
End Levee Mile	0.54
Location	Water Side
Category	Earthen Levee
Item	Encroachments

The rusty pipe is still laying on the shoulder to be picked-up.

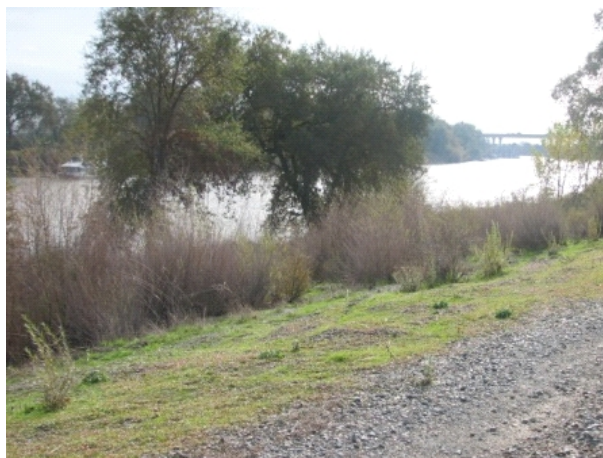
Levee Mile Report Line	7
Start Levee Mile	0.62
End Levee Mile	0.62
Location	Water Side
Category	Earthen Levee
Item	Vegetation

The sandbar willows are creeping up the levee slope.

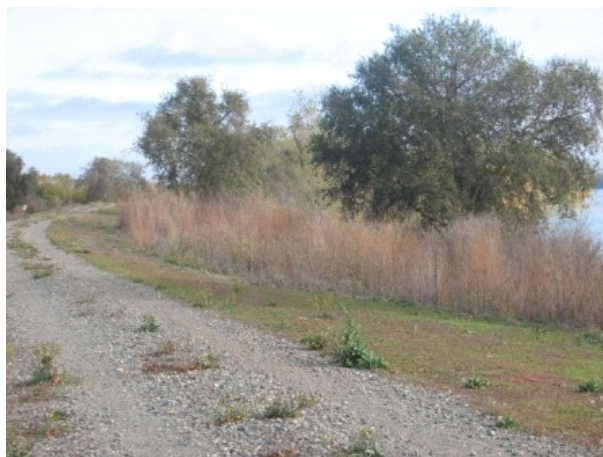
Levee Mile Report Line	8
Start Levee Mile	1.54
End Levee Mile	1.59
Location	Water Side
Category	Earthen Levee
Item	Vegetation

Sandbar willows are too far up the slope and too thick to see through.

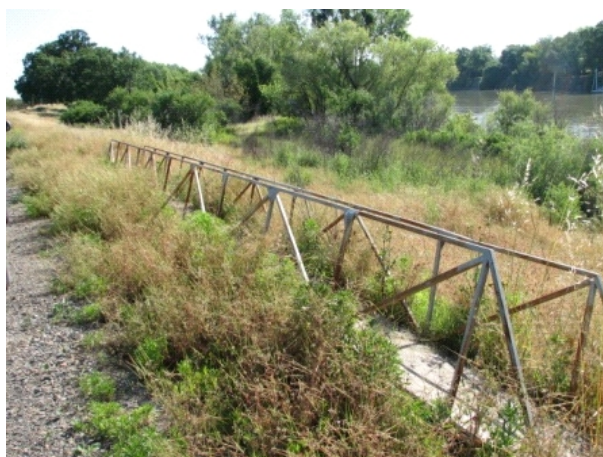
Levee Mile Report Line	9
Start Levee Mile	1.71
End Levee Mile	1.71
Location	Water Side
Category	Earthen Levee
Item	Encroachments

ramp for dock not being used

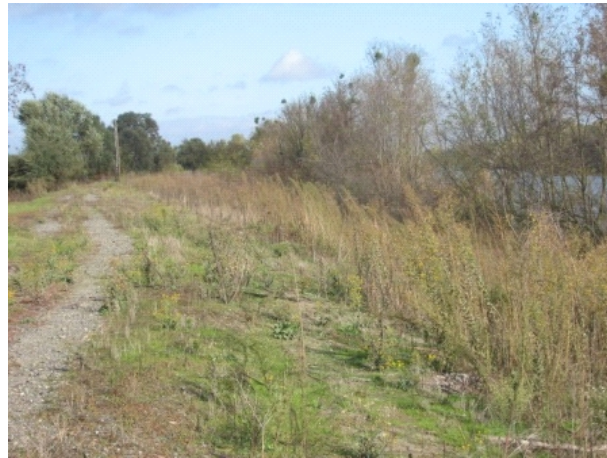
Levee Mile Report Line	10
Start Levee Mile	4.81
End Levee Mile	5.19
Location	Water Side
Category	Earthen Levee
Item	Vegetation

The vegetation is taller than 12" and a large quantity of Mares tail

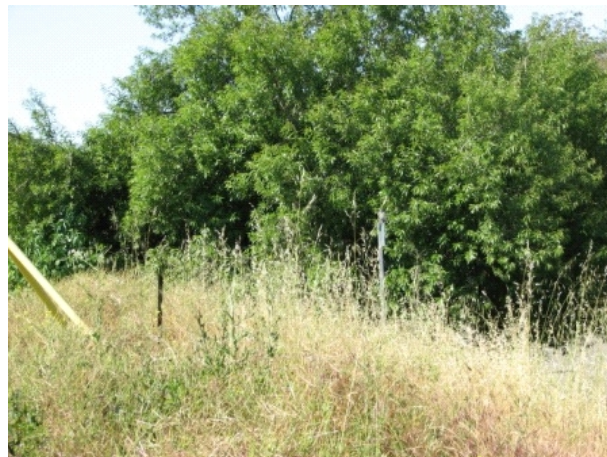
Levee Mile Report Line	13
Start Levee Mile	5.88
End Levee Mile	5.88
Location	Land Side
Category	Earthen Levee
Item	Trim / Thin Trees

Almond tree blocking levee slope view.

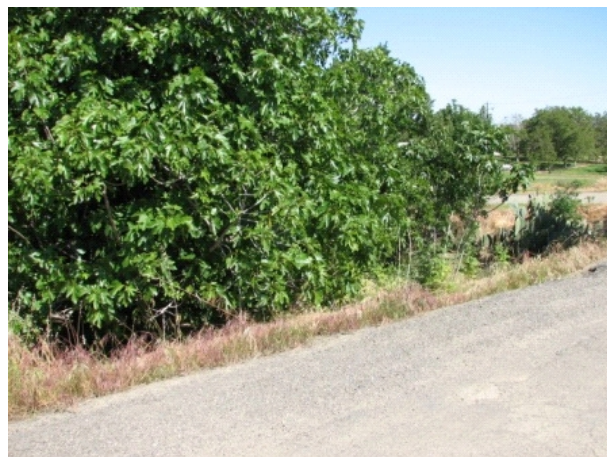
Levee Mile Report Line	15
Start Levee Mile	6.33
End Levee Mile	6.33
Location	Land Side
Category	Earthen Levee
Item	Trim / Thin Trees

fig tree on levee slope, cactus in back ground

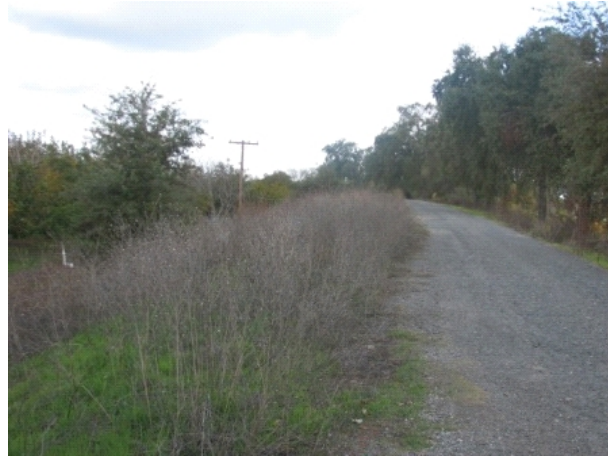
Levee Mile Report Line	16
Start Levee Mile	6.61
End Levee Mile	6.73
Location	Land Side
Category	Earthen Levee
Item	Vegetation

The vegetation is taller than 12".

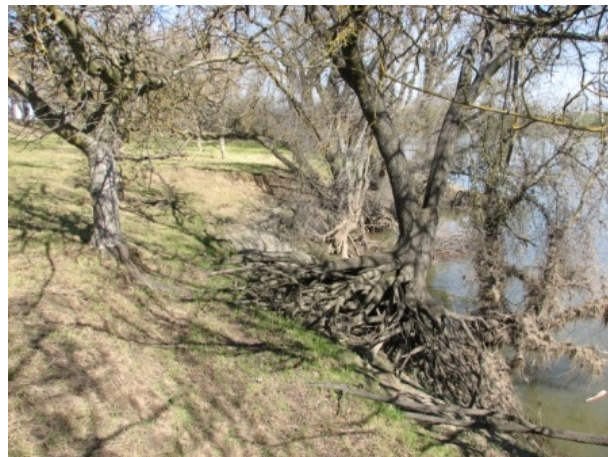
Levee Mile Report Line	17
Start Levee Mile	7.00
End Levee Mile	7.00
Location	Water Side
Category	Earthen Levee
Item	Erosion / Bank Caving

The erosion is continuing to erode the berm area.

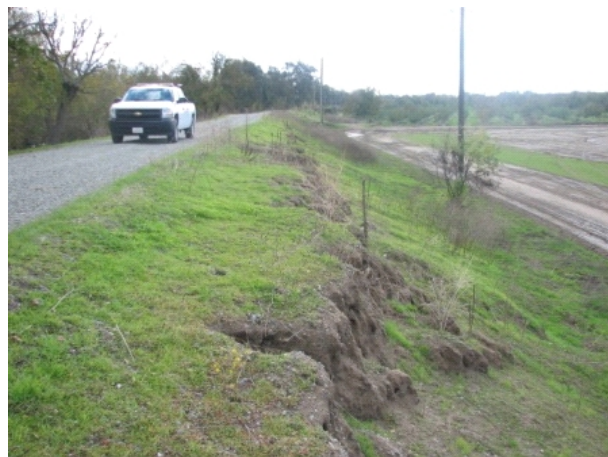
Levee Mile Report Line	18
Start Levee Mile	7.02
End Levee Mile	7.02
Location	Land Side
Category	Earthen Levee
Item	Erosion / Bank Caving

The erosion appears to be moving closer to the shoulder.

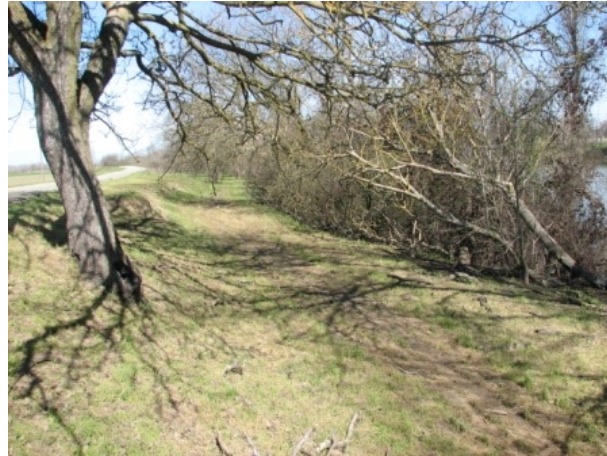
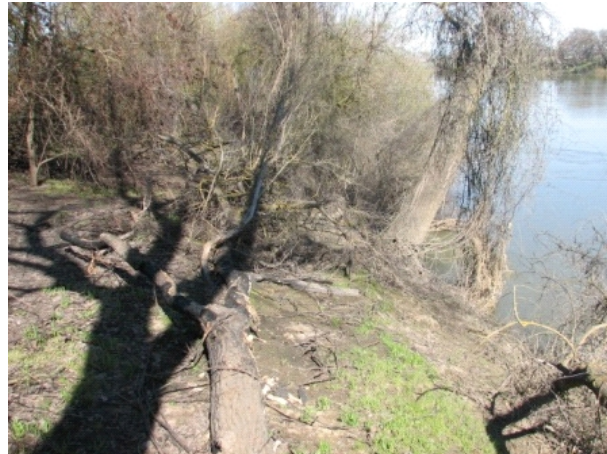
Levee Mile Report Line	19
Start Levee Mile	7.13
End Levee Mile	7.13
Location	Water Side
Category	Earthen Levee
Item	Erosion / Bank Caving

The erosion is eroding away at the berm area.

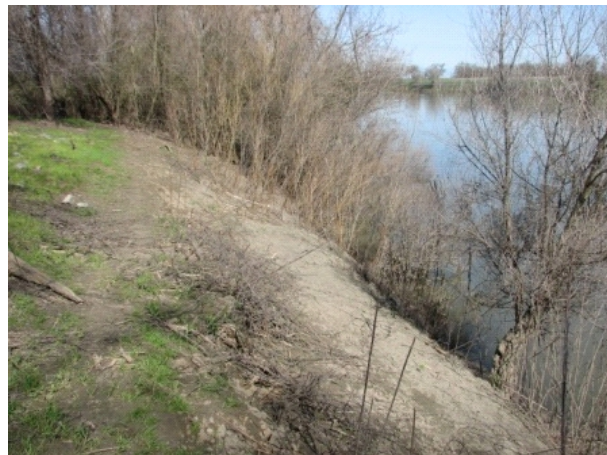
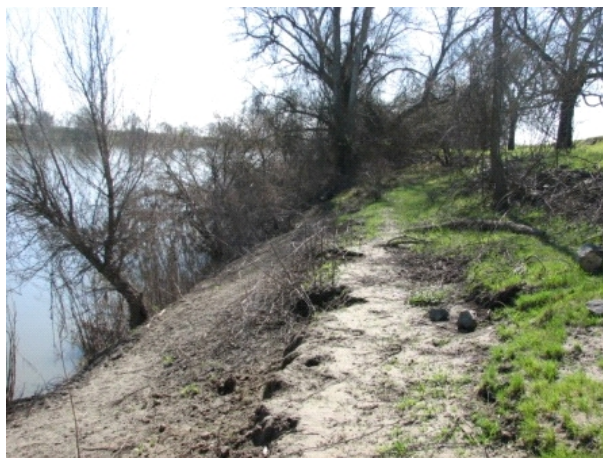
Levee Mile Report Line	20
Start Levee Mile	7.27
End Levee Mile	7.27
Location	Water Side
Category	Earthen Levee
Item	Erosion / Bank Caving

The bank is eroding away and has become very steep.

The erosion is eroding away the berm area.

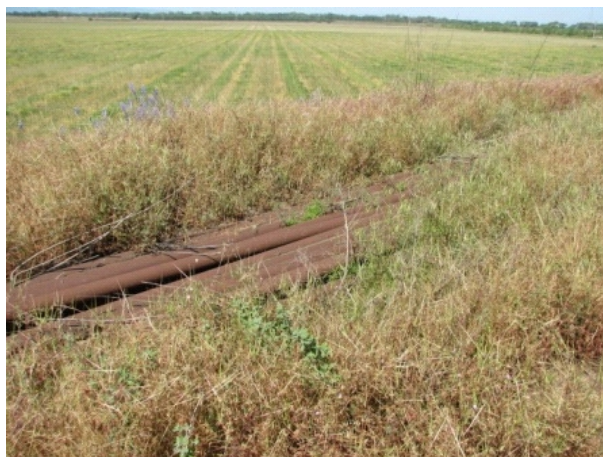
Levee Mile Report Line	21
Start Levee Mile	7.85
End Levee Mile	7.85
Location	Land Side
Category	Earthen Levee
Item	Encroachments

drilling pipe on levee crown landside

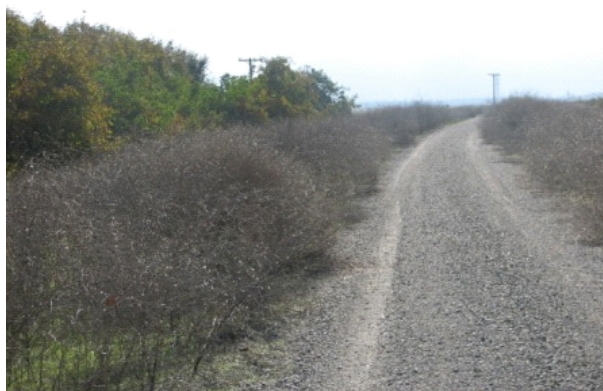
Levee Mile Report Line	24
Start Levee Mile	9.96
End Levee Mile	10.31
Location	Land Side
Category	Earthen Levee
Item	Vegetation

The vegetation is taller than 12" and makes viewing the slope hard.

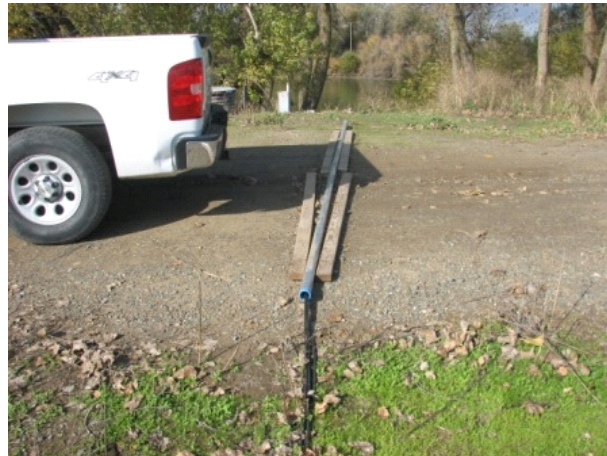
Levee Mile Report Line	25
Start Levee Mile	10.42
End Levee Mile	10.42
Location	Crown
Category	Earthen Levee
Item	Encroachments

Electrical power is laying across the levee needs to get a permit.

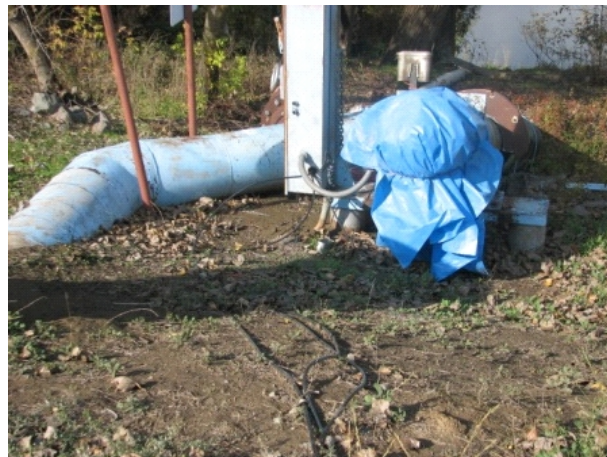
A photo of the wires on the ground and the tie in to the pump.

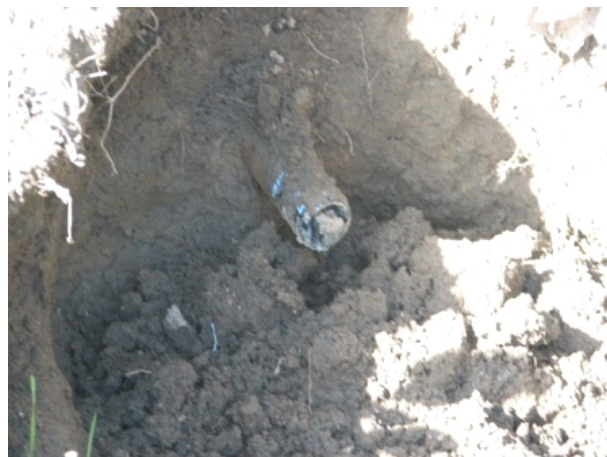
The photo is the old conduit with the old wire cut off.

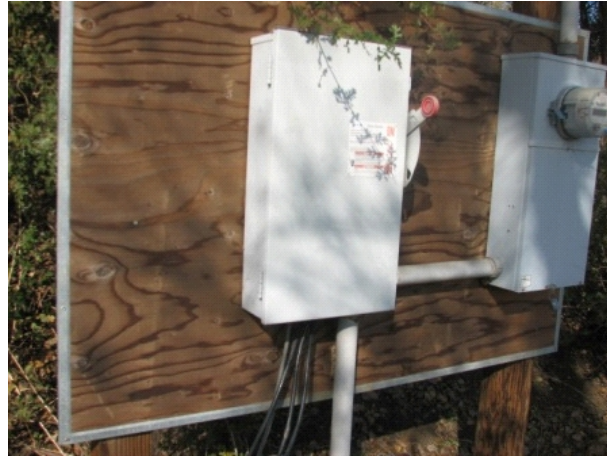
The electrical box on the landside toe.

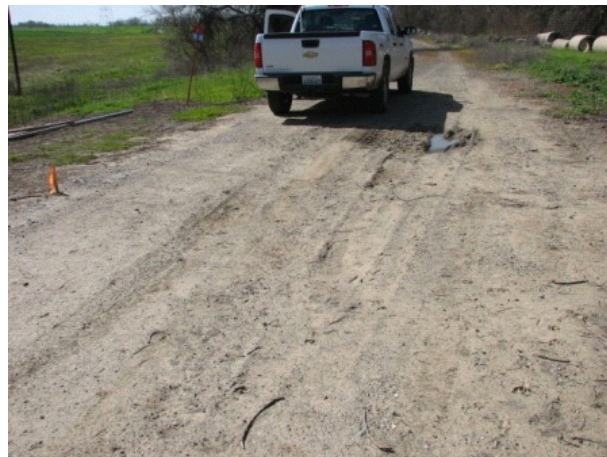
The temporary electrical wire has been removed at this time. The power has not been restored.

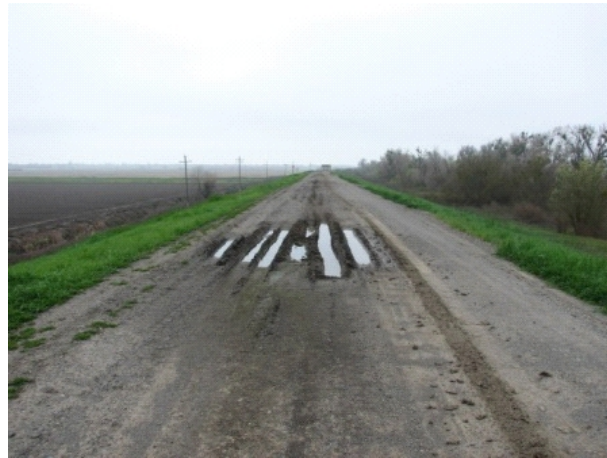
Levee Mile Report Line	1
Start Levee Mile	0.07
End Levee Mile	0.07
Location	Crown
Category	Earthen Levee
Item	Crown Surface / Depressions / Rutting
The levee crown has some soft spots with rutting in some areas.	
johngw_s_20110314_377.jpg

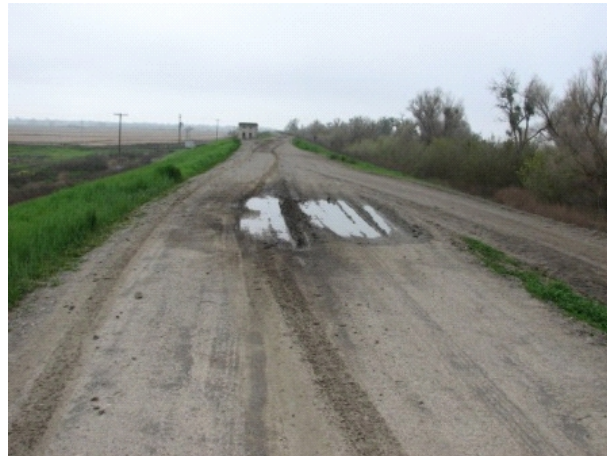
Levee Mile Report Line	2
Start Levee Mile	0.22
End Levee Mile	0.22
Location	Crown
Category	Earthen Levee
Item	Crown Surface / Depressions / Rutting
The crown needs to be graded and AB added to the crown.	
johngw_s_20110314_378.jpg

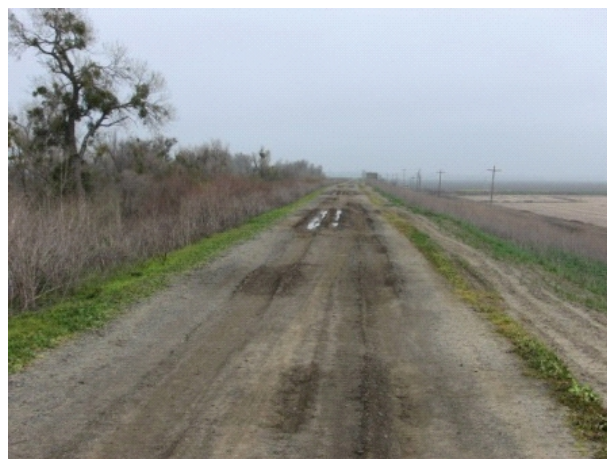
Levee Mile Report Line	7
Start Levee Mile	0.68
End Levee Mile	0.77
Location	Crown
Category	Earthen Levee
Item	Crown Surface / Depressions / Rutting
This area is soft and needs to have AB added to make an all weather surface.	
johngw_s_20110314_379.jpg

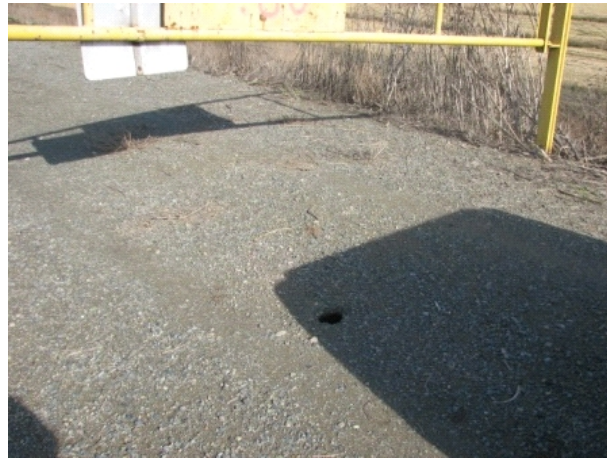
Levee Mile Report Line	8
Start Levee Mile	0.81
End Levee Mile	0.81
Location	Crown
Category	Earthen Levee
Item	Animal Control

A 4" diameter hole is in the levee crown caused by a rodent.

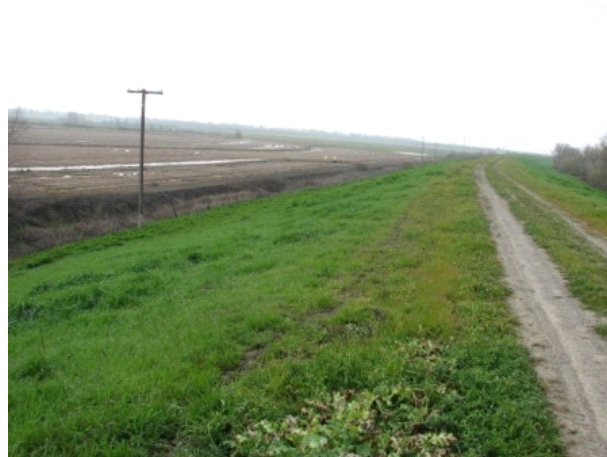
Levee Mile Report Line	9
Start Levee Mile	0.91
End Levee Mile	0.91
Location	Land Side
Category	Earthen Levee
Item	Vegetation

A view of the landside slope with grasses less than 12".

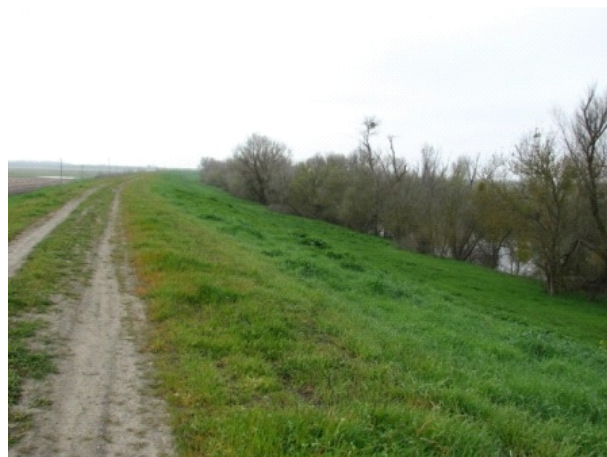
Levee Mile Report Line	10
Start Levee Mile	0.91
End Levee Mile	0.91
Location	Water Side
Category	Earthen Levee
Item	Vegetation

Waterside view of the slope with grasses less than 12".

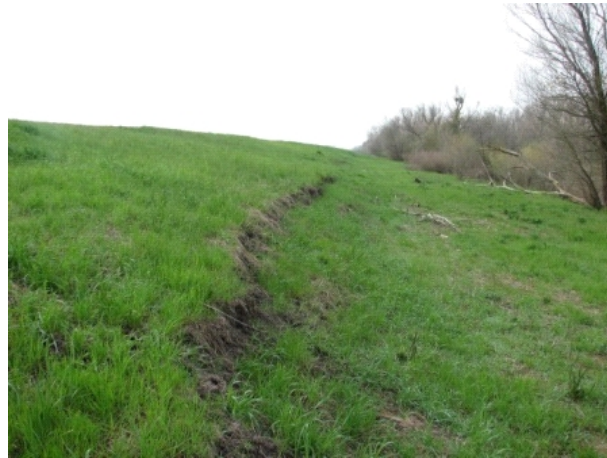
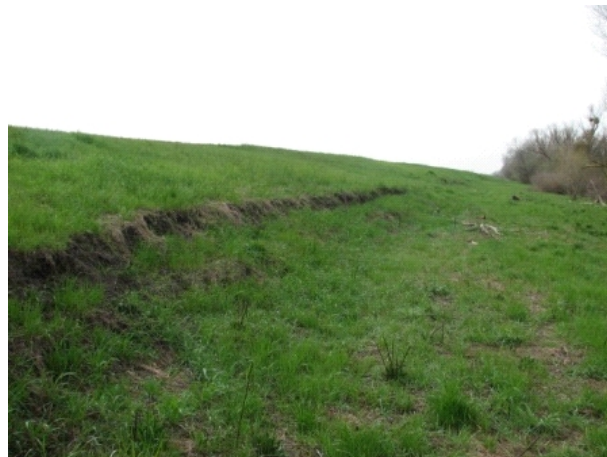
Levee Mile Report Line	12
Start Levee Mile	1.74
End Levee Mile	2.01
Location	Water Side
Category	Earthen Levee
Item	Erosion / Bank Caving

Wave wash damage along the slope the cut is 1'-2'.

A closer view of the wave wash damage along the bypass.

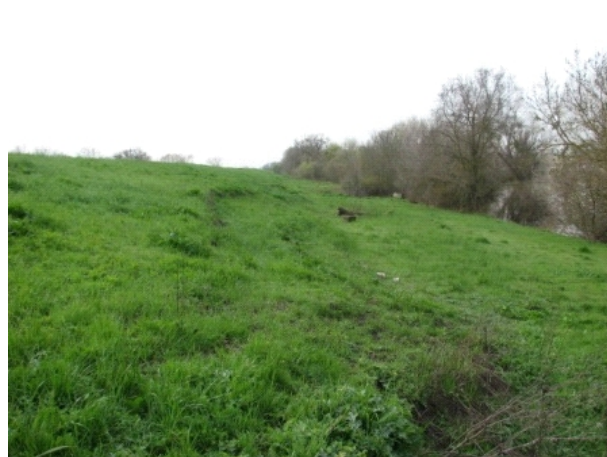
Levee Mile Report Line	13
Start Levee Mile	2.12
End Levee Mile	2.23
Location	Water Side
Category	Earthen Levee
Item	Erosion / Bank Caving

This is wave wash damage along the toe of the levee looking downstream.

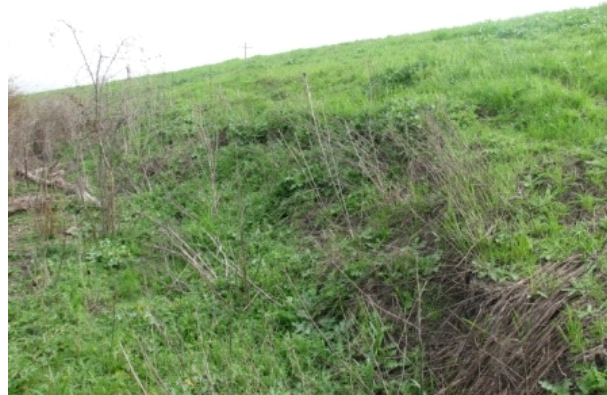
Levee Mile Report Line	13
Start Levee Mile	2.12
End Levee Mile	2.23
Location	Water Side
Category	Earthen Levee
Item	Erosion / Bank Caving
Looking upstream a deeper cut of 2'-3' damage.	
johngw_s_20110314_385.jpg
